Customer : Lotte Chemical Titan Sdn Bhd
Address : PLO 312, Jalan Tembaga 4, Pasir Gudang Industrial Estate, 81700 Pasir Gudang, Johor, Malaysia
Location Area : Cogen Utility Natural Gas Station

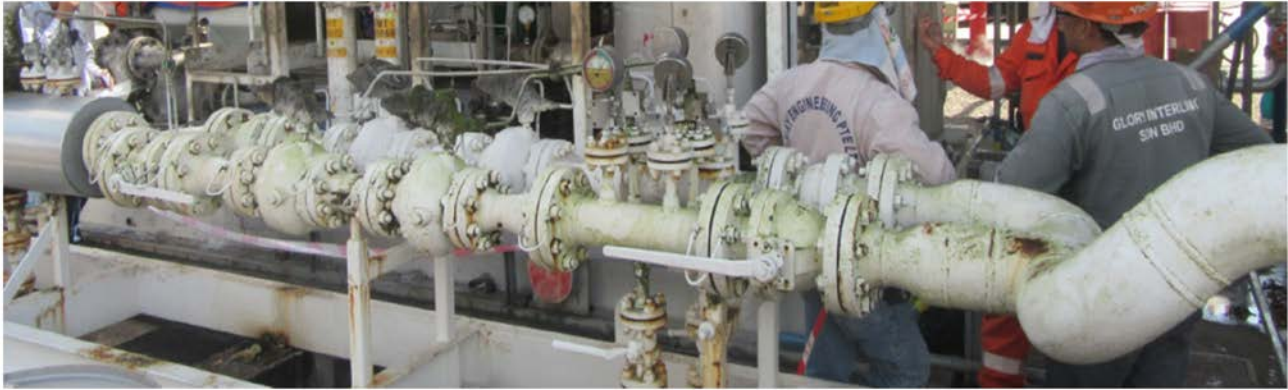
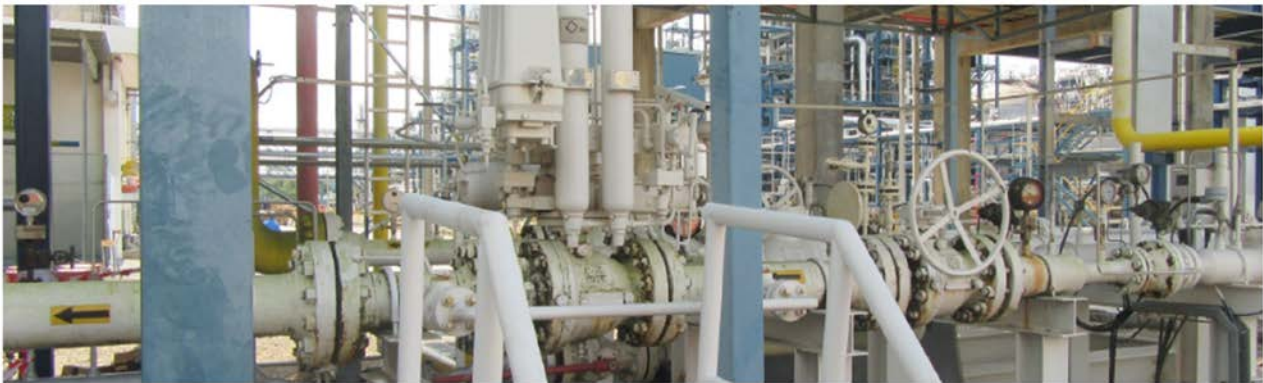
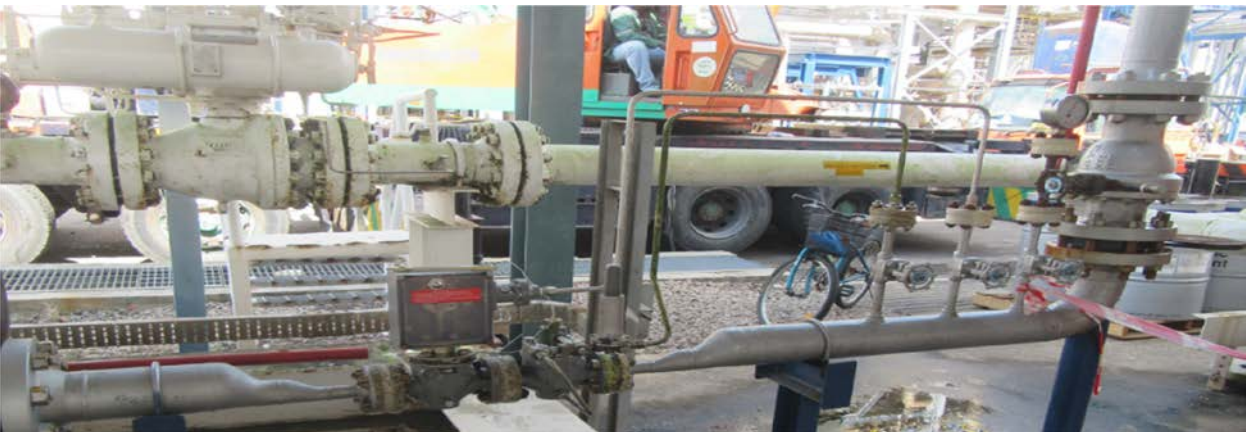
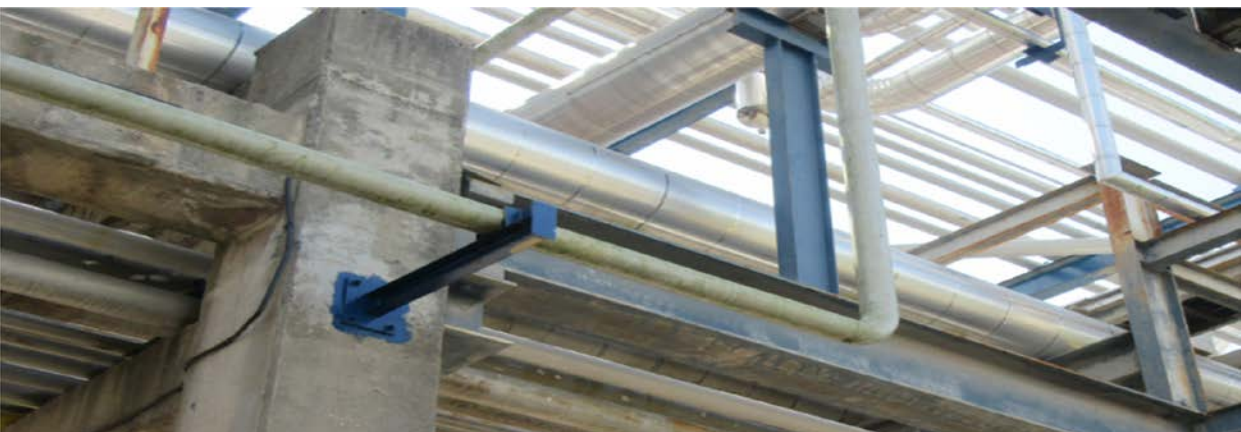
BEFORE

Gas pipeline – algae growth and corrosion

Pipeline sweating due to Nitrogen gas flowing in the pipeline

Applied Protega HBF(m) – primer (grey) and GF65(m) – PU top coat (white) on live pipeline (no shutdown)
